**Subject: Removal Action Report
Dead Creek Sediment Removal Site
Sauget, St. Clair County, Illinois
EPA Contract No. 68-W-00-129
TDD No. S05-0104-010**

REMOVAL ACTION REPORT
DEAD CREEK SEDIMENT REMOVAL
SAUGET, ST. CLAIR COUNTY, ILLINOIS

**REMOVAL ACTION REPORT
DEAD CREEK SEDIMENT REMOVAL
SAUGET, ST. CLAIR COUNTY, ILLINOIS**

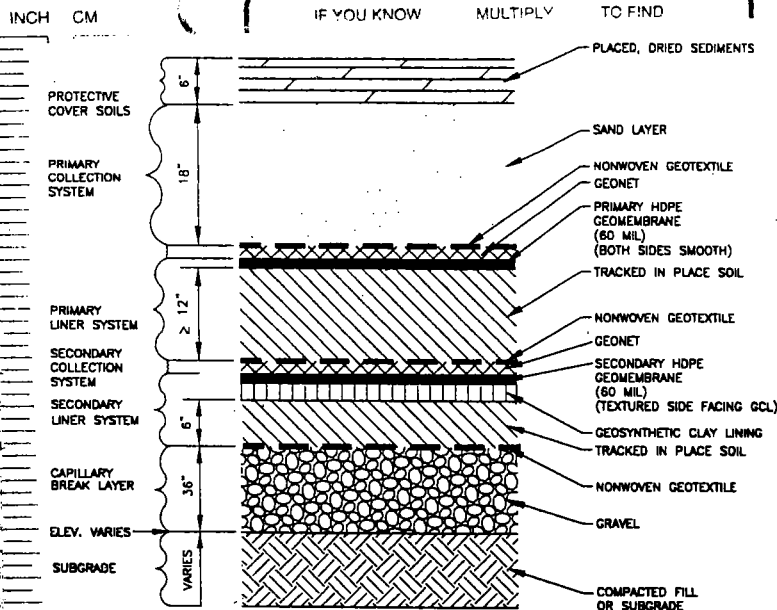
NOT FOR CONSTRUCTION.
LAYER THICKNESSES SHOWN
ARE COMPACTED THICKNESS.

SOLUTIA C100004081.00 IRS Corporation Southern 850 West Courtney Campbell Causeway Apopka, FL 32807-1462 D. 00000002	Drawn: H. WEBER Design: BARRY WHITLAND Checked: BARRY WHITLAND Date: APRIL 2, 2001	PROJECT NAME SOLUTIA INC. SAUGET AREA 1 DRAWING TITLE BOTTOM LINER SYSTEM DETAIL	FIGURE 4-1
--	---	---	---------------

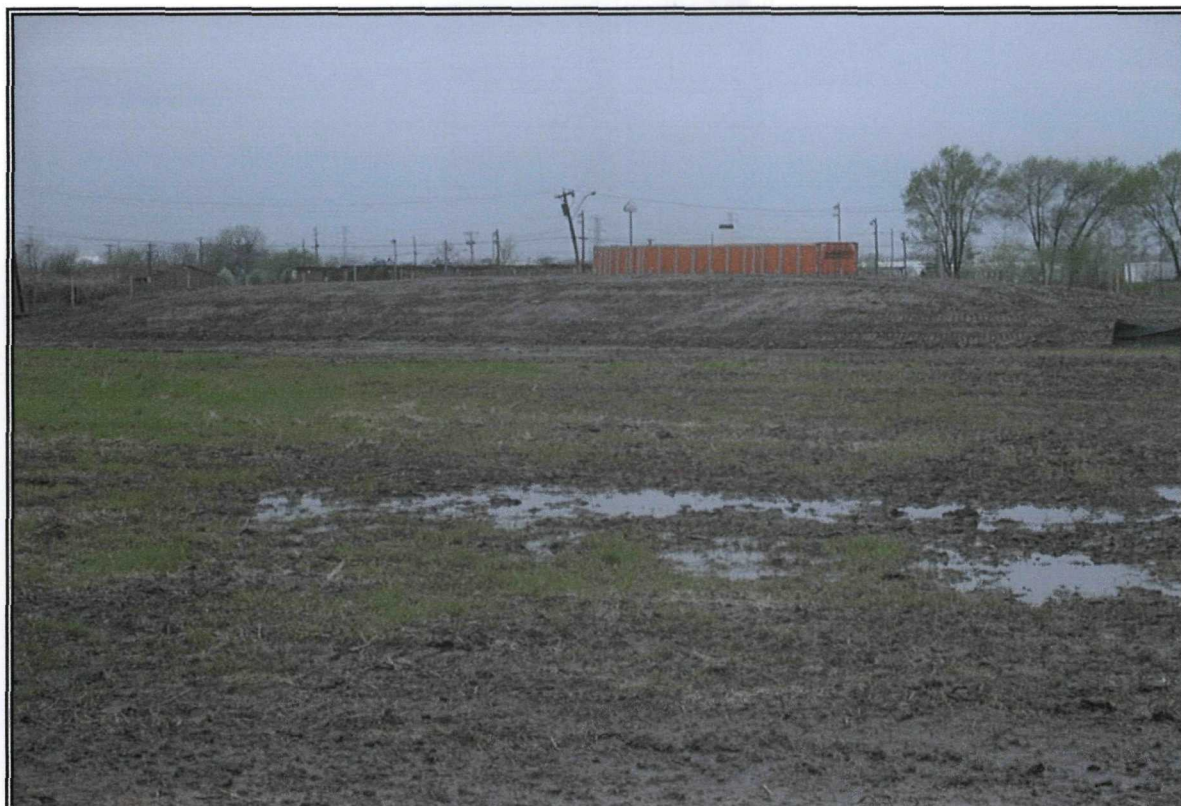
OFFICIAL PHOTOGRAPH NO. 1
U.S. ENVIRONMENTAL PROTECTION AGENCY

Subject: Rough grading of the TSCA cell site.

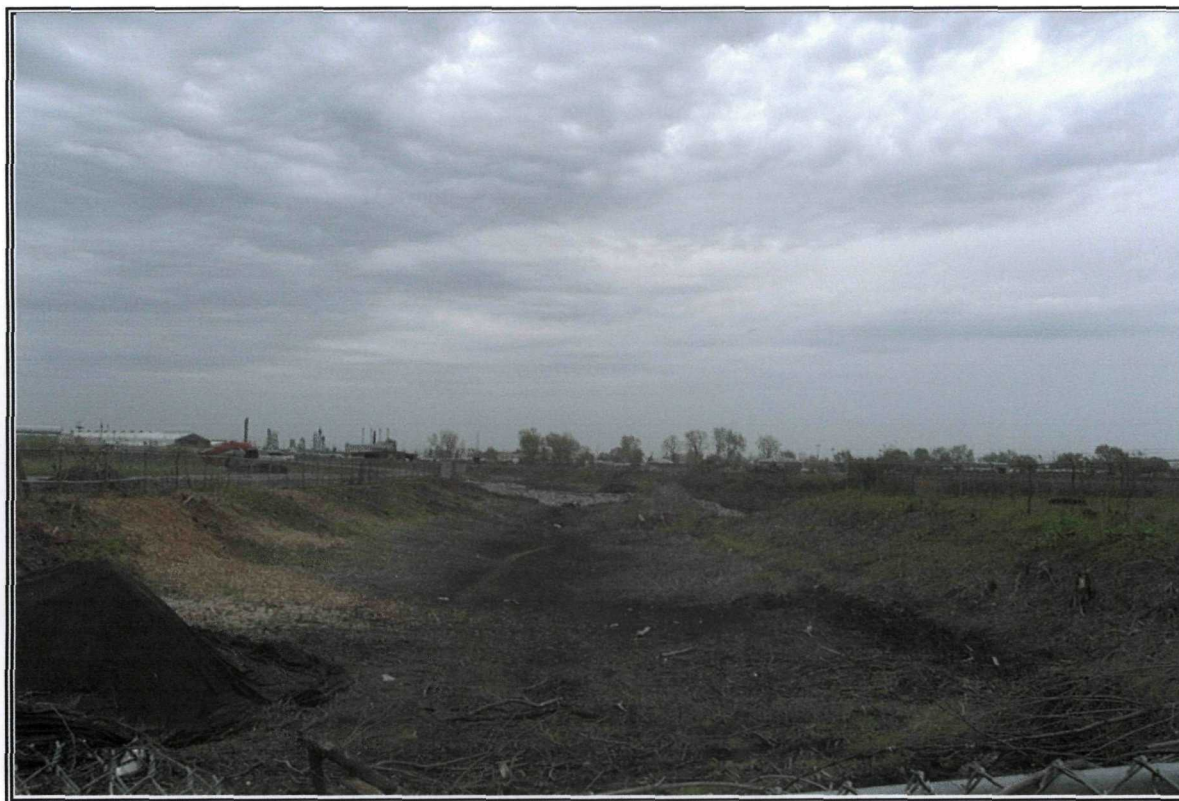
OFFICIAL PHOTOGRAPH NO. 3
U.S. ENVIRONMENTAL PROTECTION AGENCY

Subject: Segment B adjacent to the TSCA cell site.

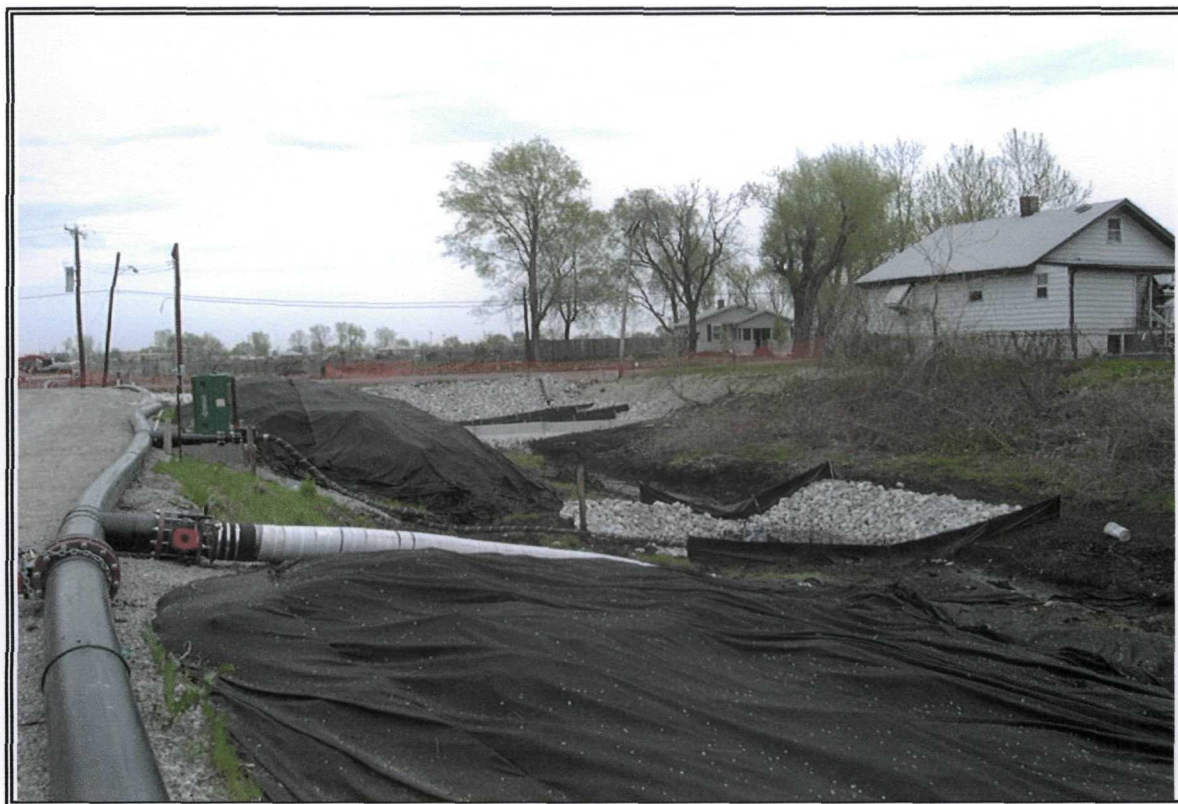
OFFICIAL PHOTOGRAPH NO. 4
U.S. ENVIRONMENTAL PROTECTION AGENCY

Subject: The creek dewatering system just downstream from Judith Lane.

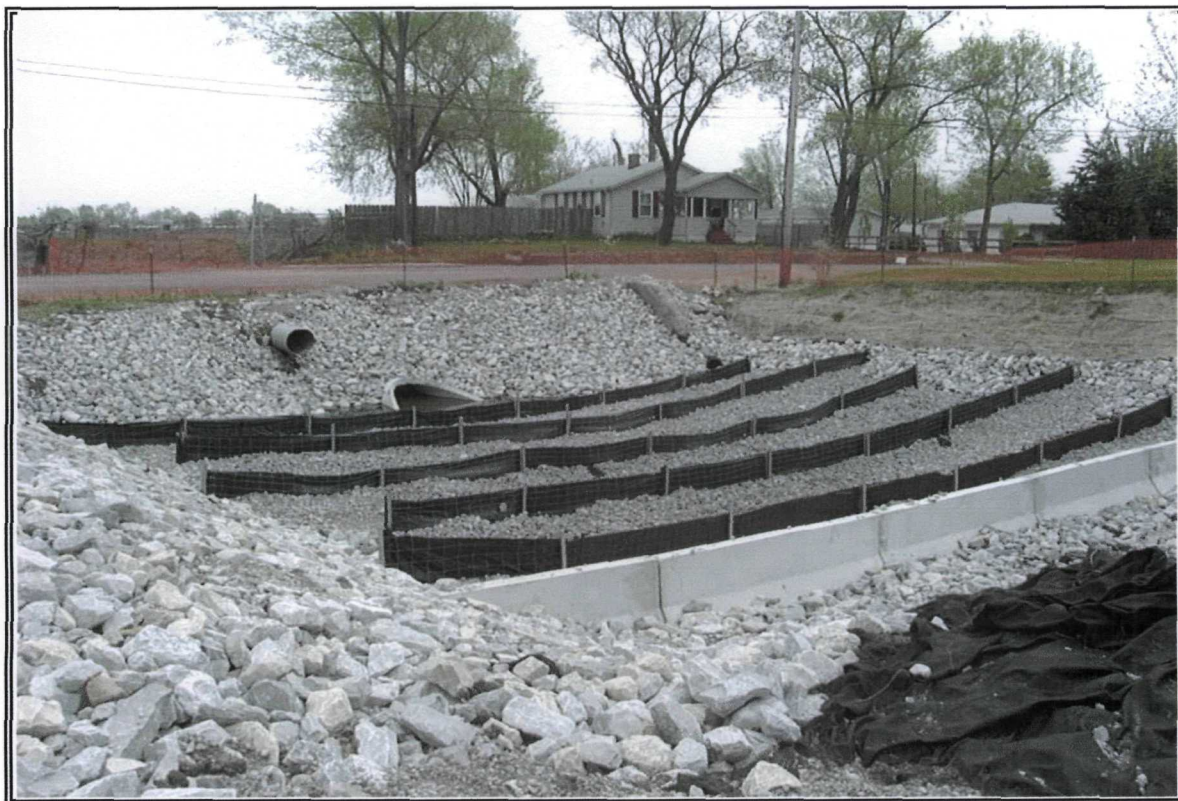
OFFICIAL PHOTOGRAPH NO. 5
U.S. ENVIRONMENTAL PROTECTION AGENCY

Subject: Sediment trap at Judith Lane.

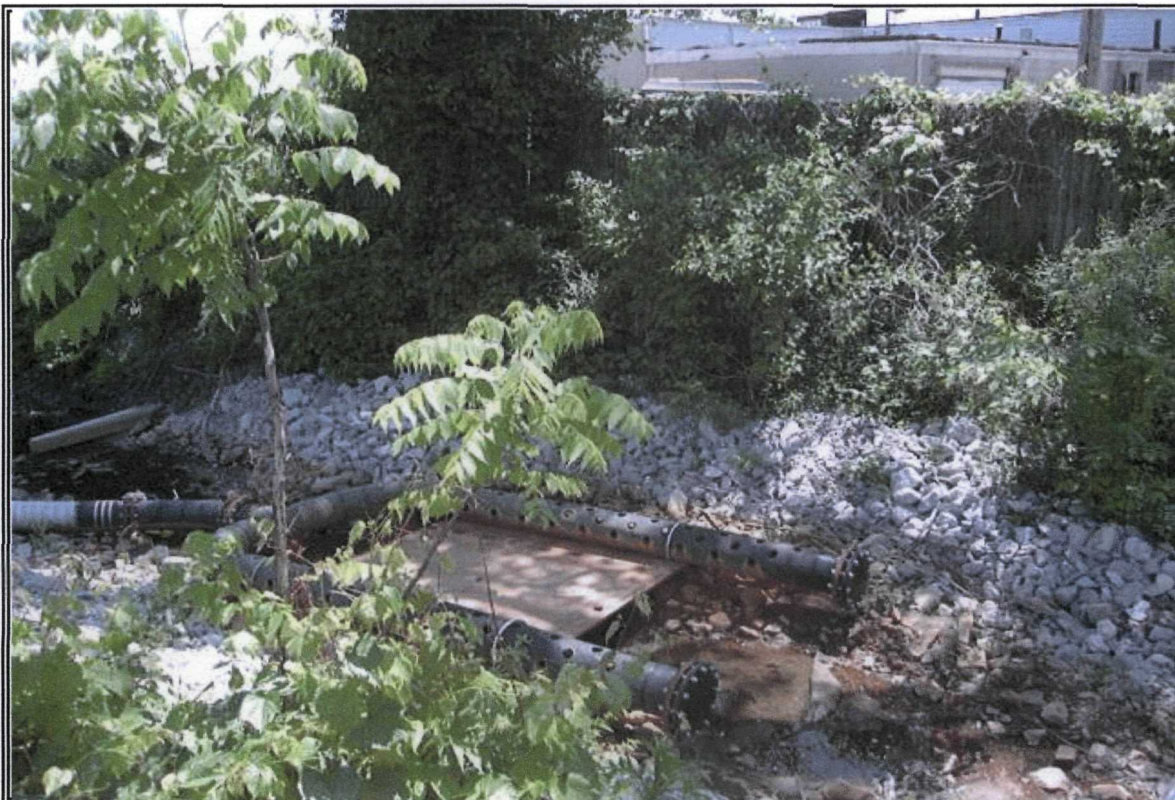
OFFICIAL PHOTOGRAPH NO. 6
U.S. ENVIRONMENTAL PROTECTION AGENCY

Subject: Flow dissipater at the end of the creek dewatering system.

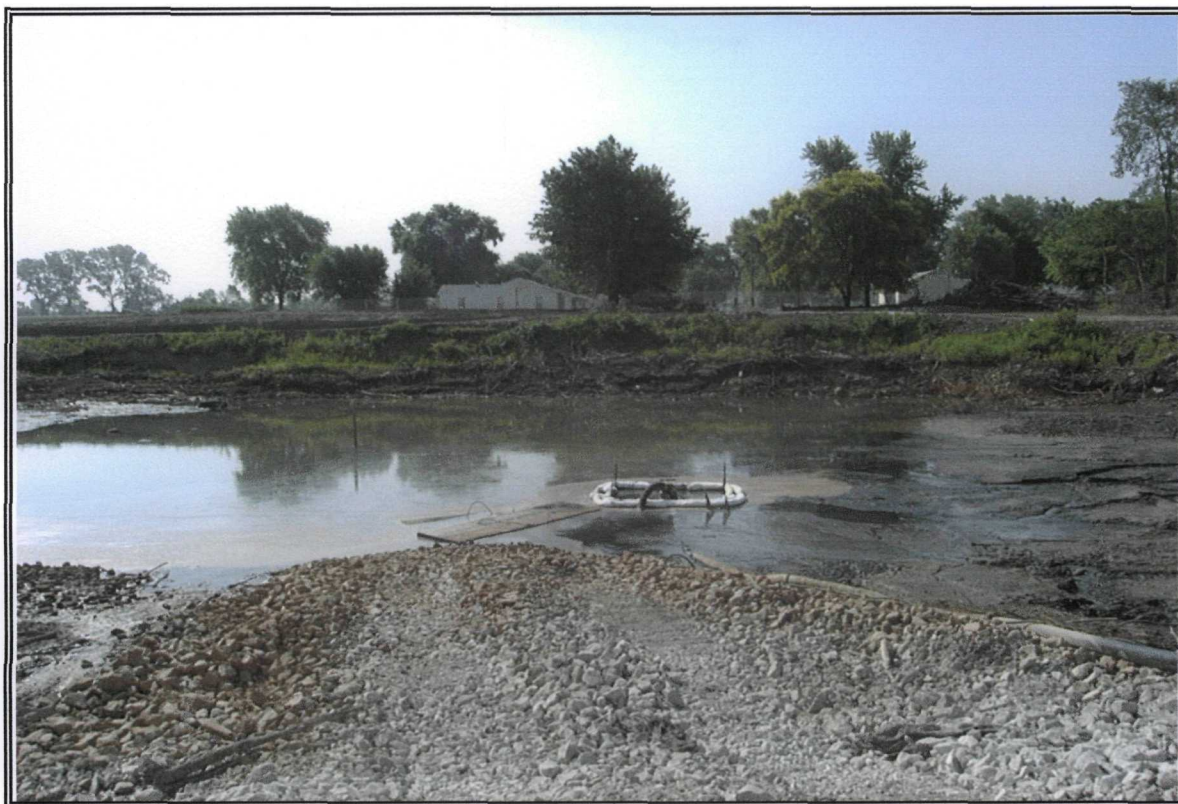
OFFICIAL PHOTOGRAPH NO. 7
U.S. ENVIRONMENTAL PROTECTION AGENCY

Subject: Dewatering Site M.

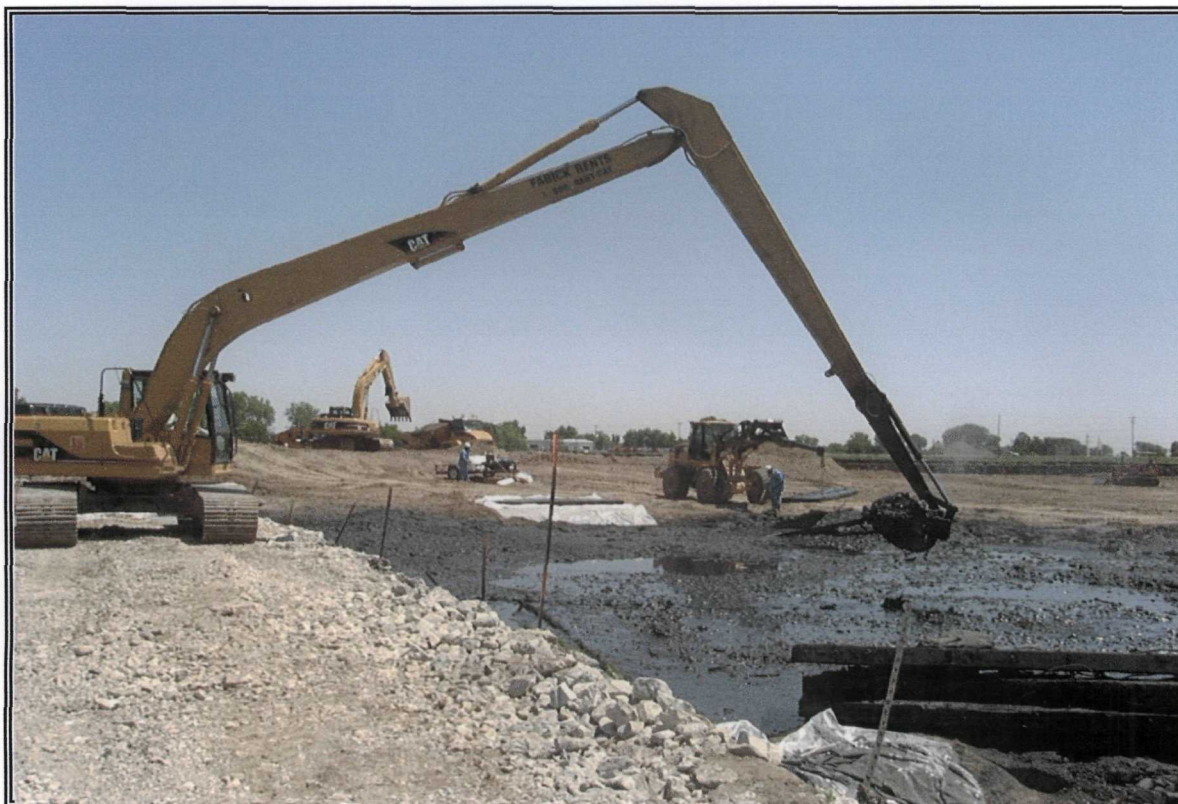
OFFICIAL PHOTOGRAPH NO. 8
U.S. ENVIRONMENTAL PROTECTION AGENCY

Subject: Removing sediment from Site M with a longstick backhoe.

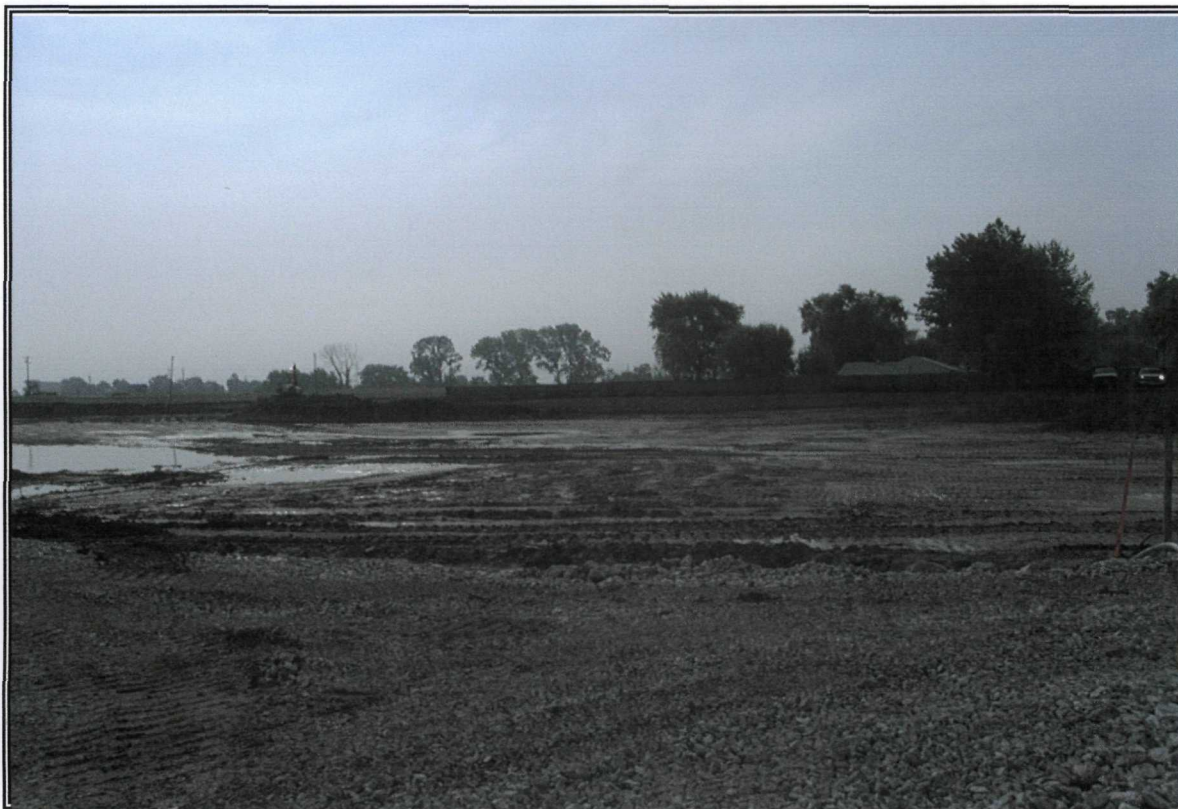
OFFICIAL PHOTOGRAPH NO. 9
U.S. ENVIRONMENTAL PROTECTION AGENCY

Subject: Site M after the removal was completed and clean fill was placed in the excavation.

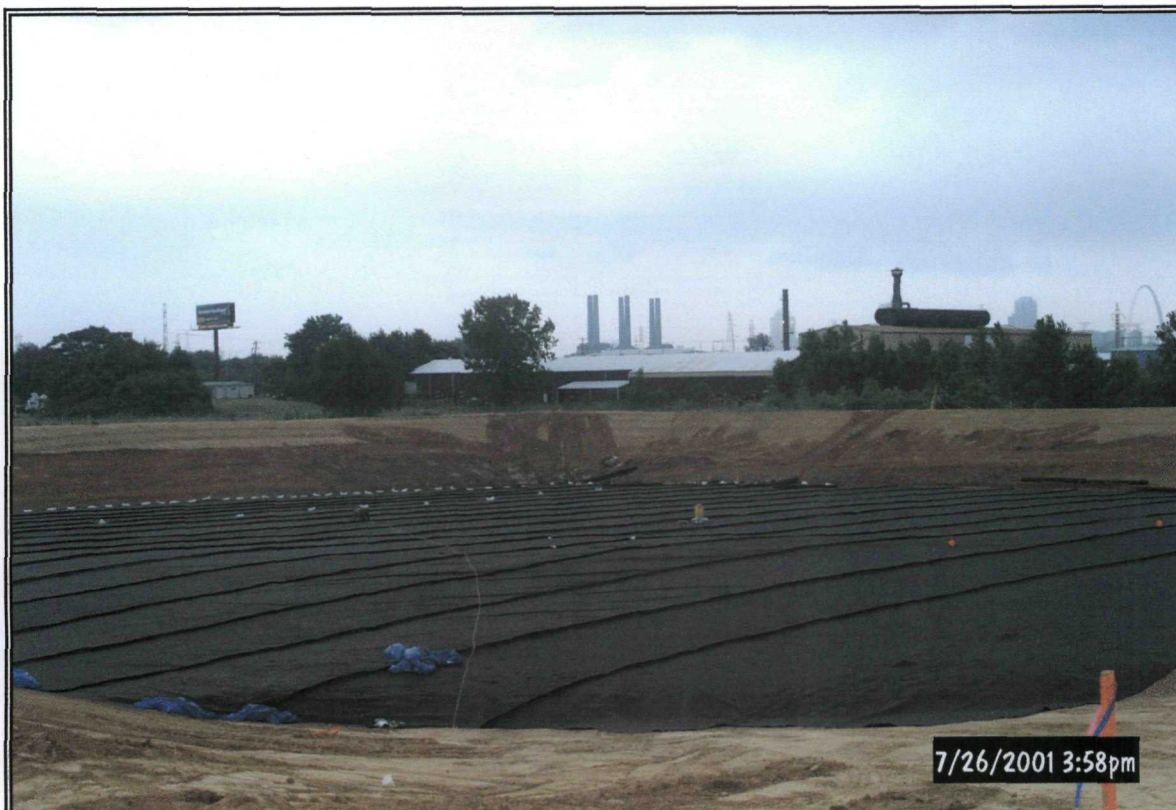
OFFICIAL PHOTOGRAPH NO. 10
U.S. ENVIRONMENTAL PROTECTION AGENCY

Subject: The secondary liner geotextile layer.

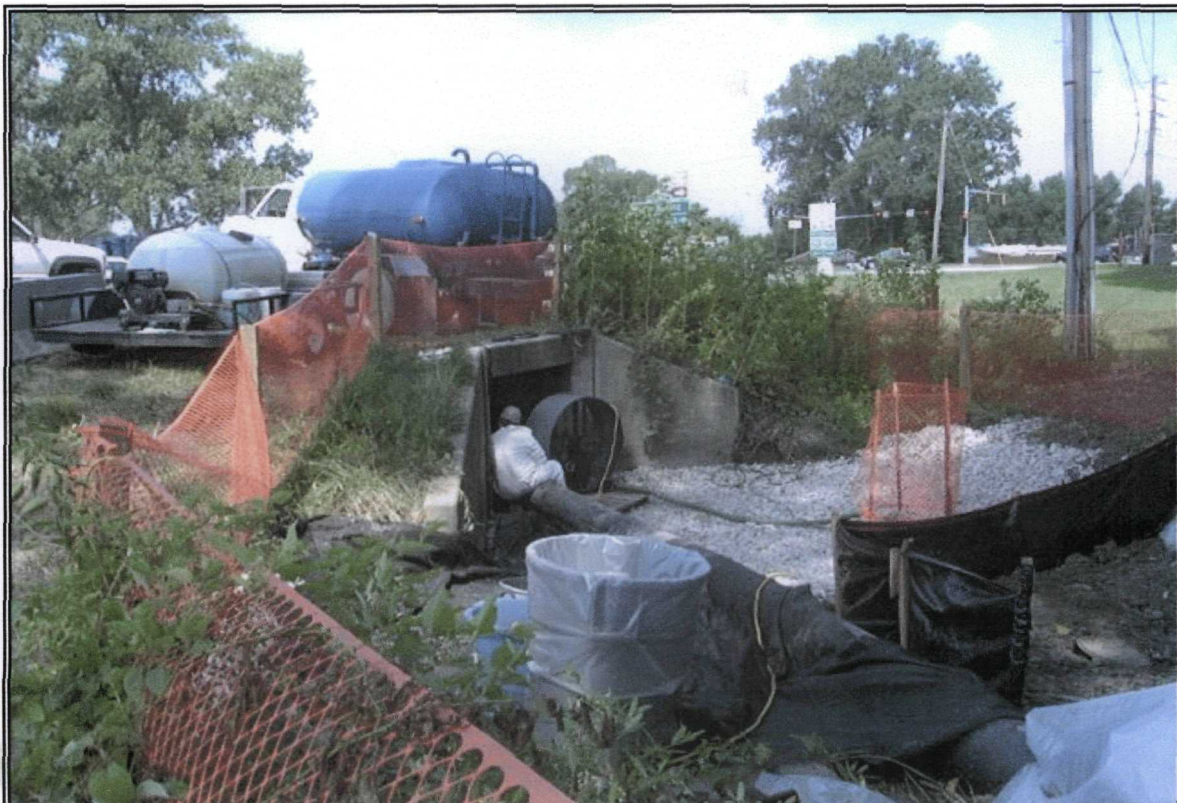
OFFICIAL PHOTOGRAPH NO. 11
U.S. ENVIRONMENTAL PROTECTION AGENCY

Subject: Cleaning the culvert passing under Highway 157.

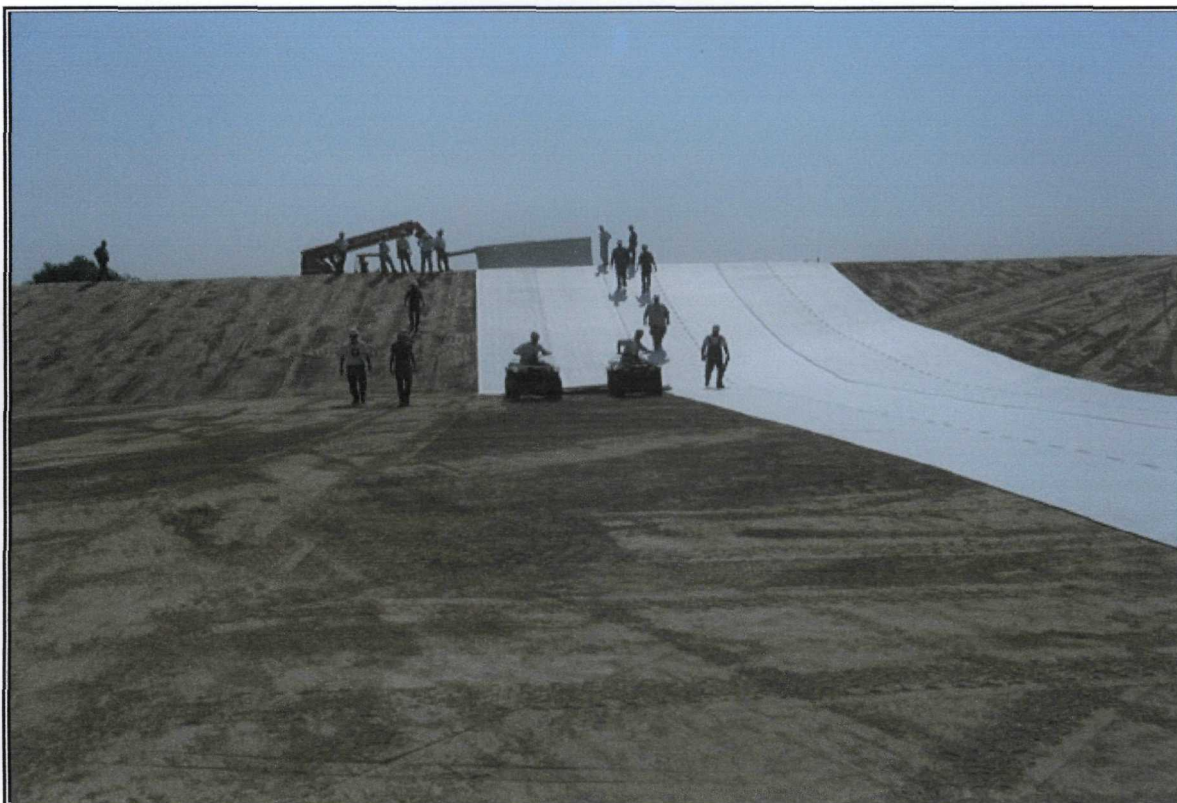
OFFICIAL PHOTOGRAPH NO. 12
U.S. ENVIRONMENTAL PROTECTION AGENCY

Subject: Deployment of GCL layer in the secondary liner.

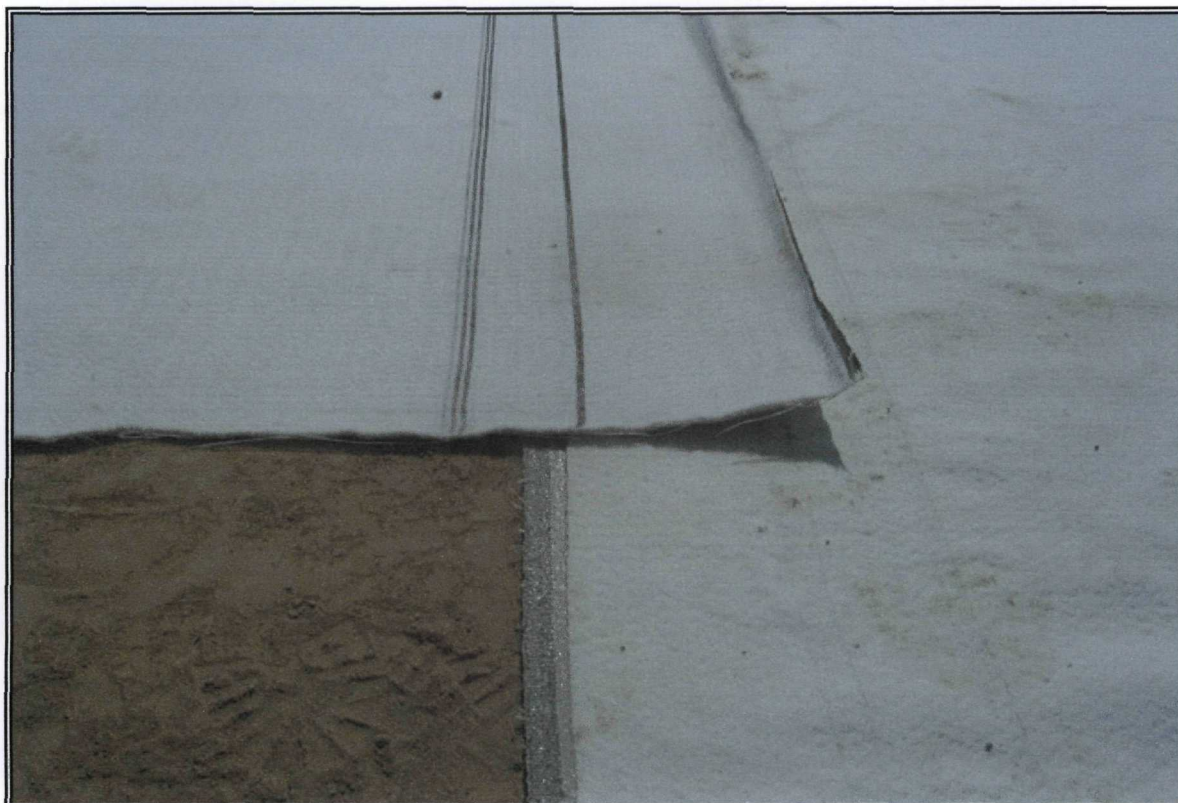
OFFICIAL PHOTOGRAPH NO. 13
U.S. ENVIRONMENTAL PROTECTION AGENCY

Subject: Overlap between GCL rolls in the secondary liner.

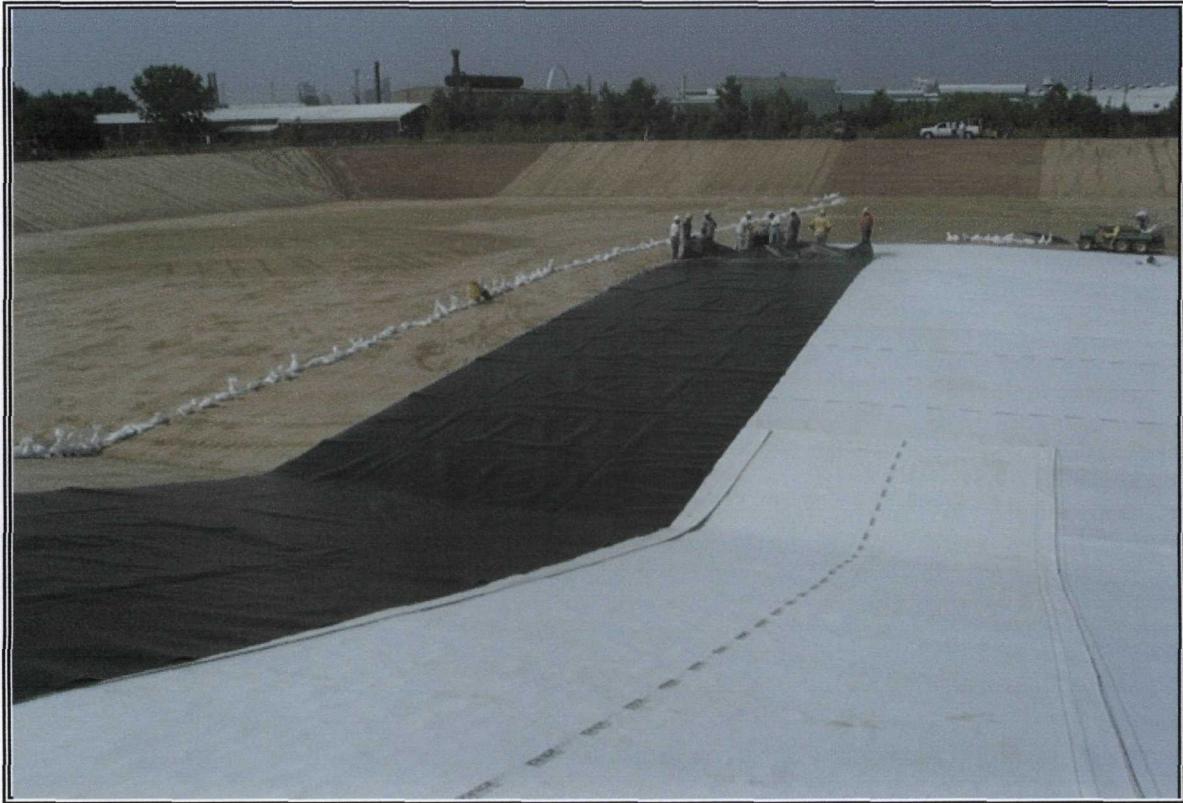
OFFICIAL PHOTOGRAPH NO. 14
U.S. ENVIRONMENTAL PROTECTION AGENCY

Subject: Deployment of geomembrane layer over the GCL in the secondary liner.

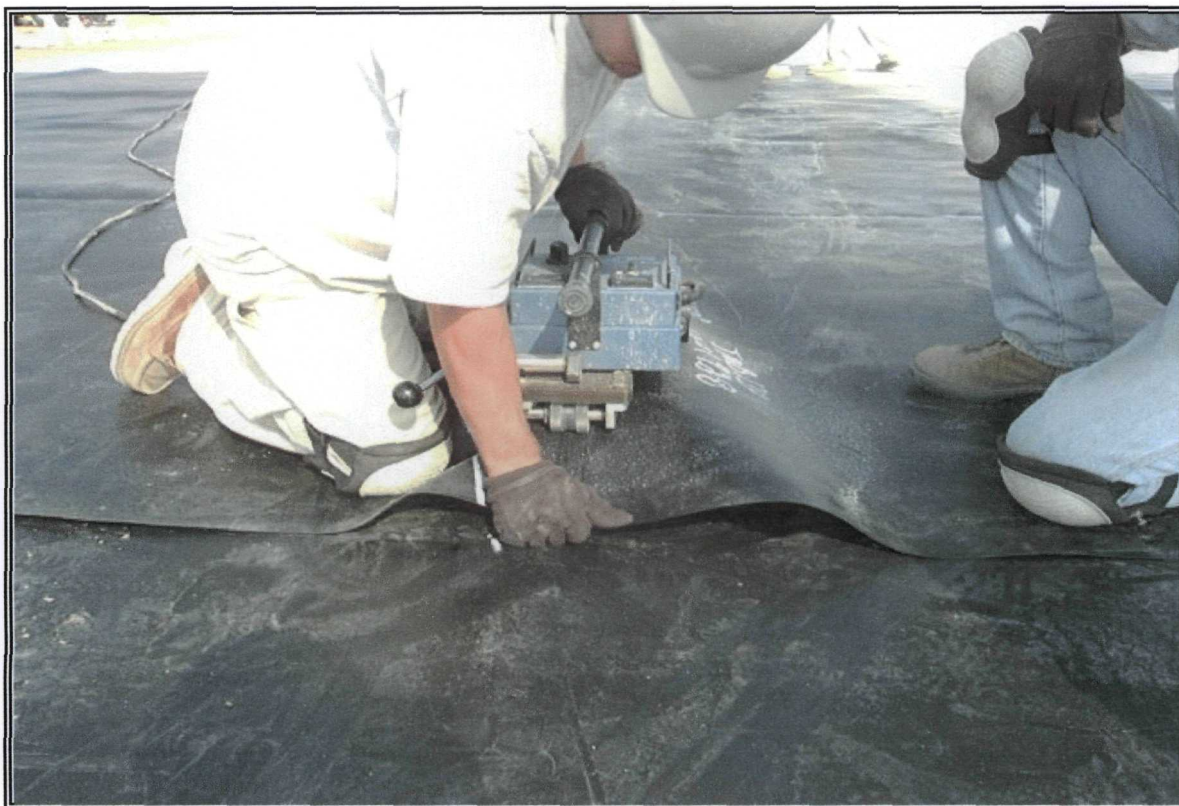
OFFICIAL PHOTOGRAPH NO. 15
U.S. ENVIRONMENTAL PROTECTION AGENCY

Subject: Welding the seam between two geomembrane rolls in the secondary liner.

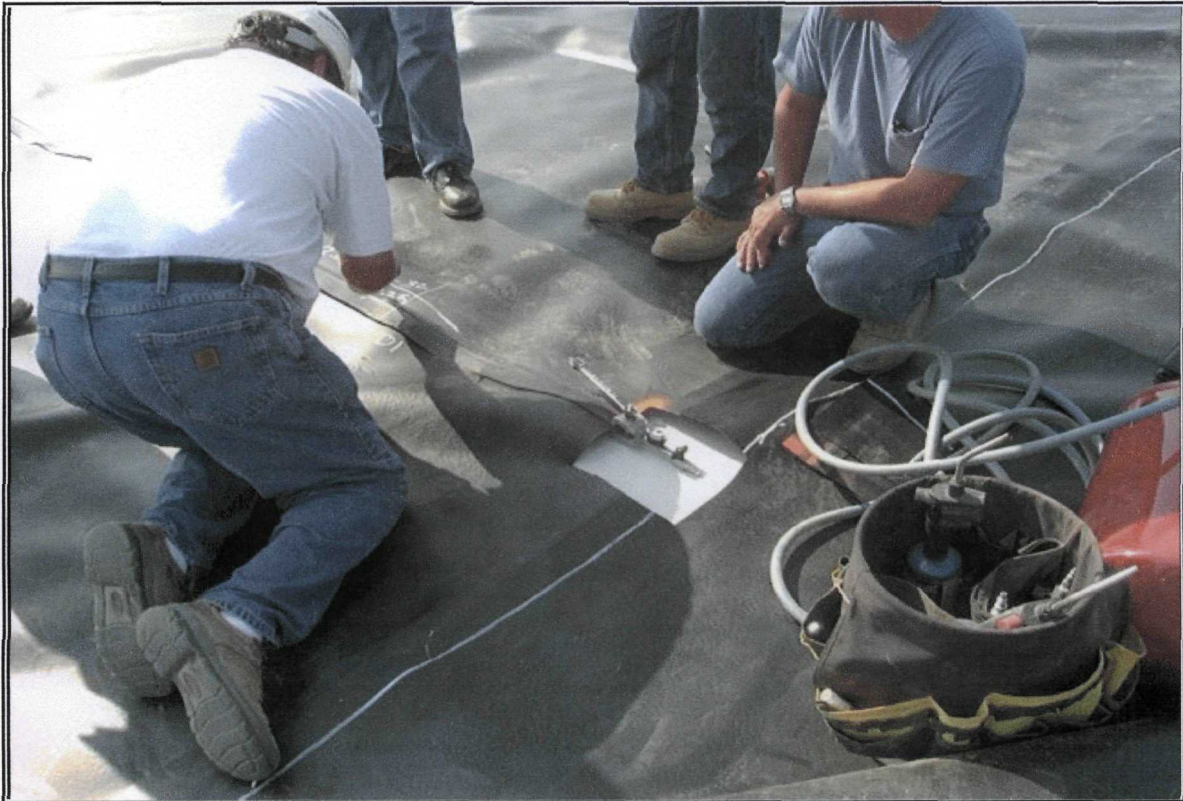
OFFICIAL PHOTOGRAPH NO. 16
U.S. ENVIRONMENTAL PROTECTION AGENCY

Subject: Air testing a geomembrane seam in the secondary liner.

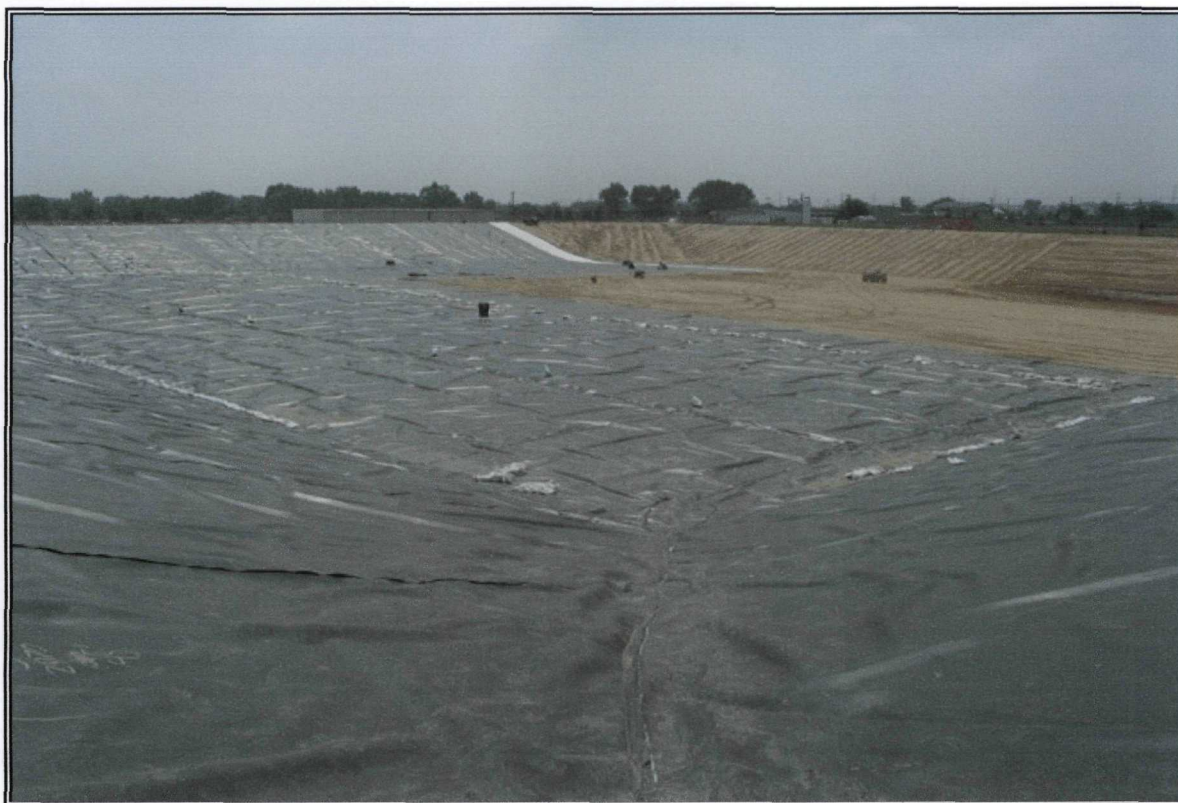
OFFICIAL PHOTOGRAPH NO. 17
U.S. ENVIRONMENTAL PROTECTION AGENCY

Subject: Geomembrane layer of the secondary liner covering most of the cell.

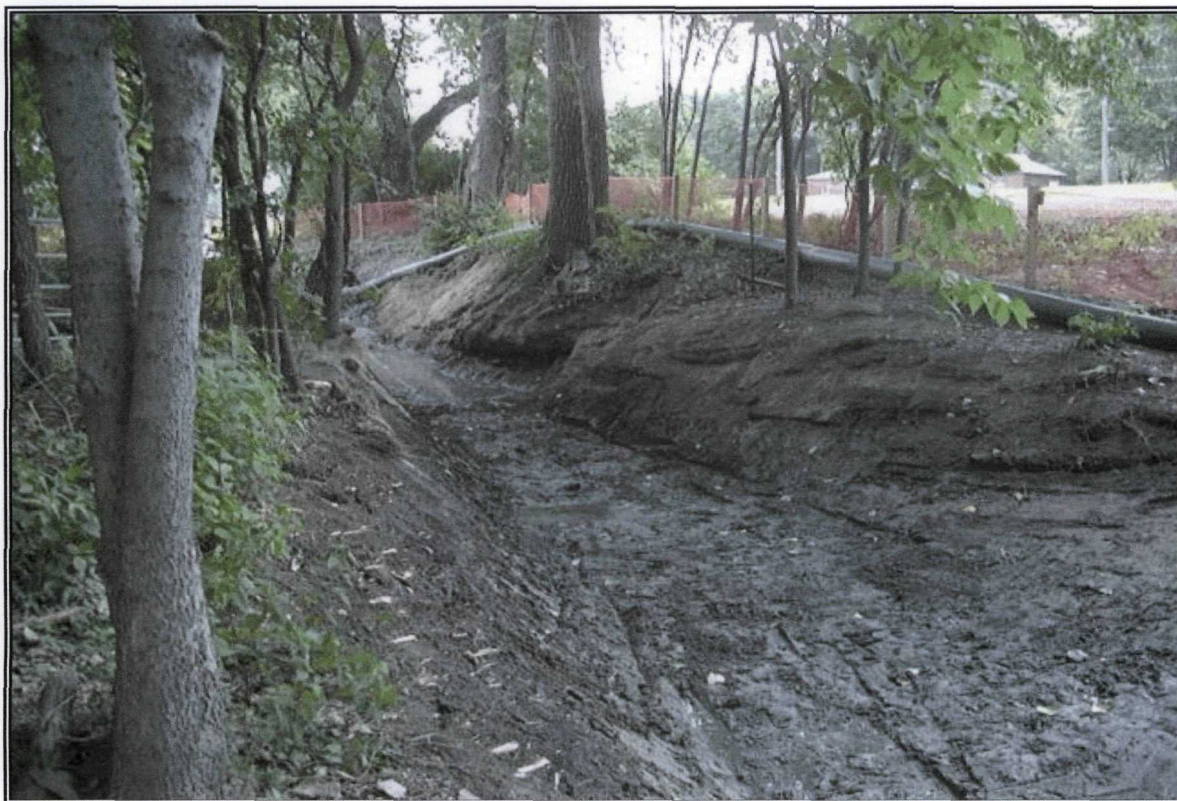
OFFICIAL PHOTOGRAPH NO. 18
U.S. ENVIRONMENTAL PROTECTION AGENCY

Subject: Portion of Segment D with contaminated sediment removed.

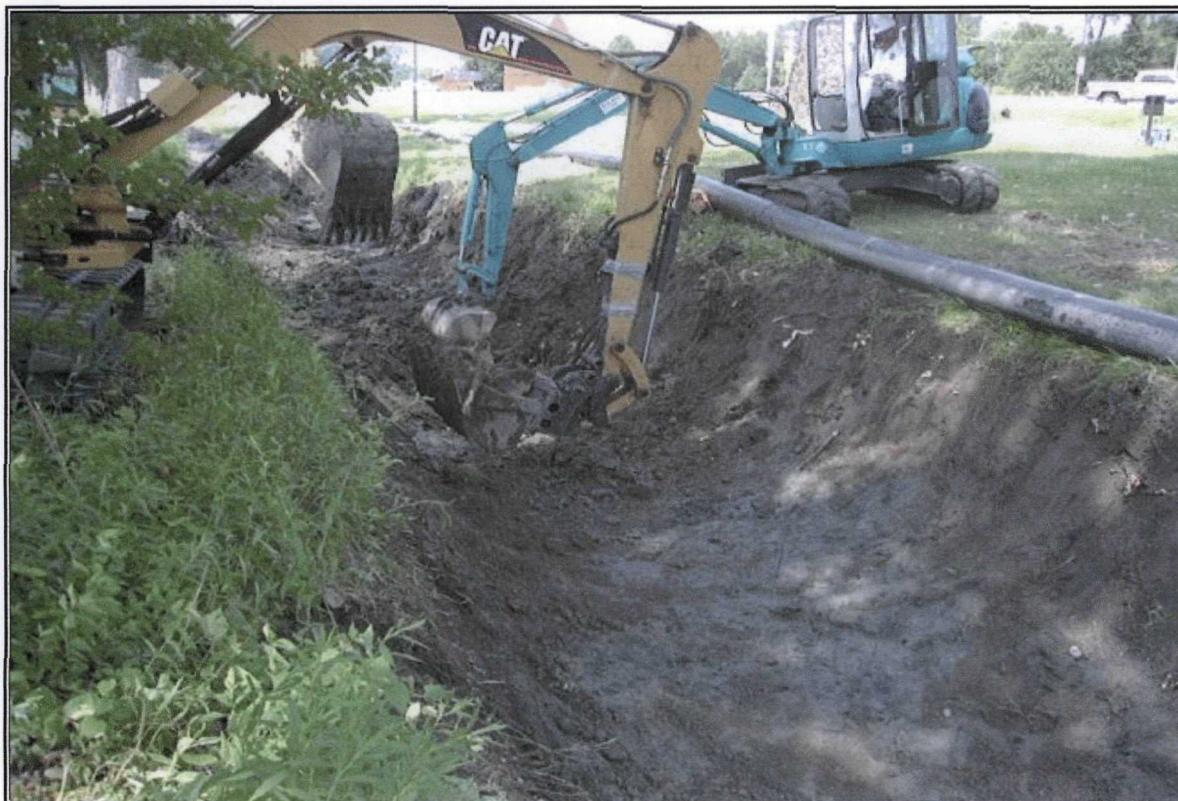
OFFICIAL PHOTOGRAPH NO. 19
U.S. ENVIRONMENTAL PROTECTION AGENCY

Subject: Sediment being removed from Segment E near the intersection of Highways 3 and 157.

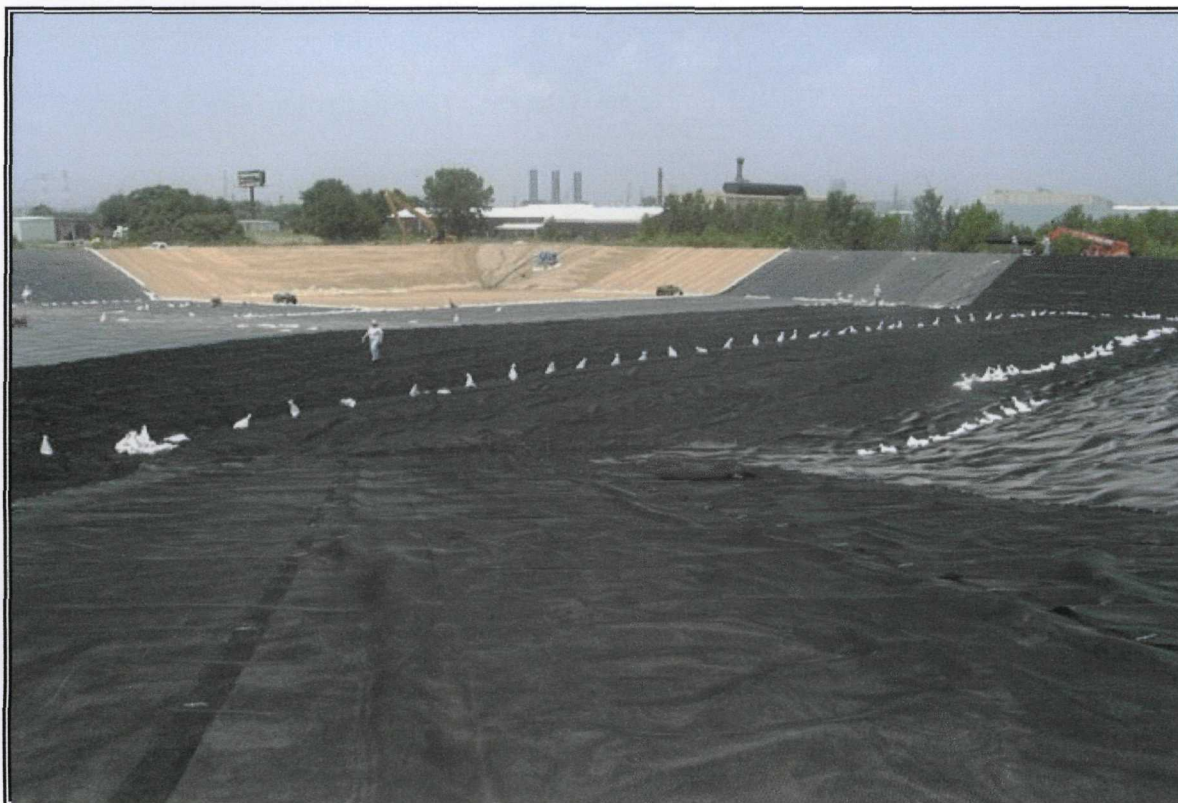
OFFICIAL PHOTOGRAPH NO. 20
U.S. ENVIRONMENTAL PROTECTION AGENCY

Subject: Partial coverage of the Geonet layer in the secondary liner.

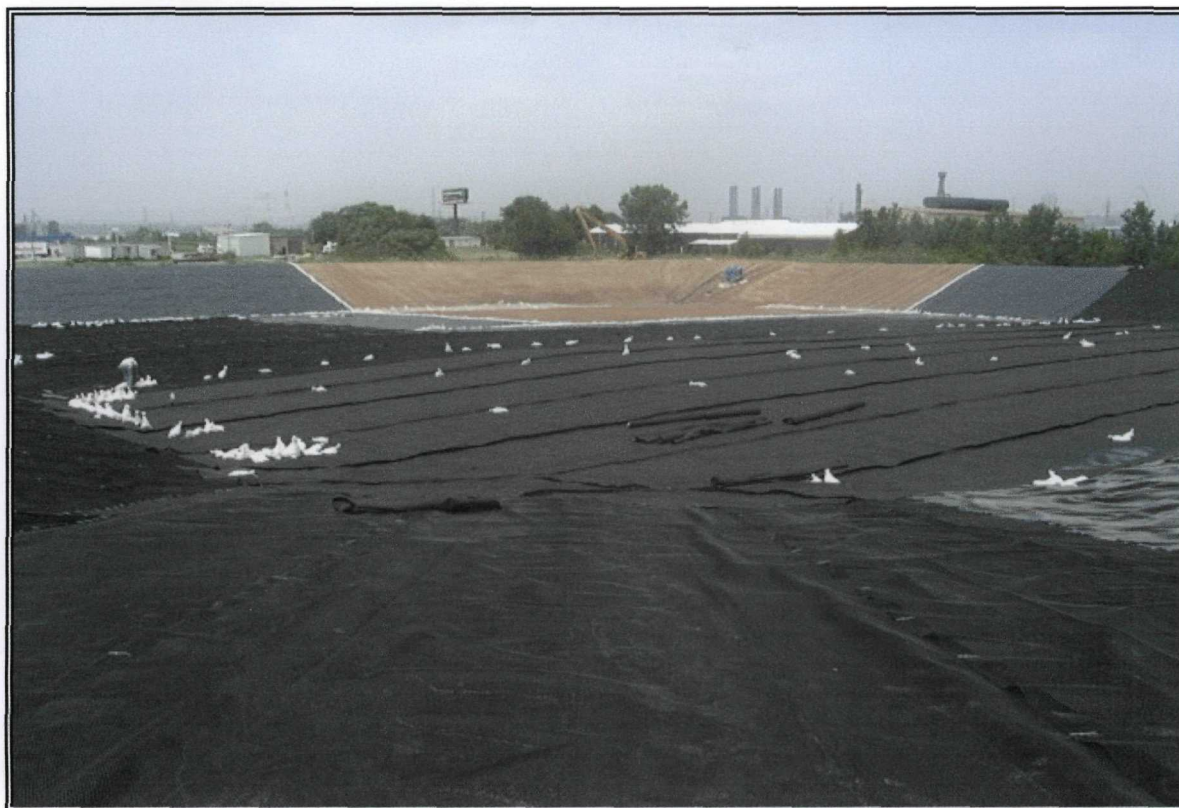
OFFICIAL PHOTOGRAPH NO. 21
U.S. ENVIRONMENTAL PROTECTION AGENCY

Subject: Installation of the second layer of geotextile in the secondary liner.

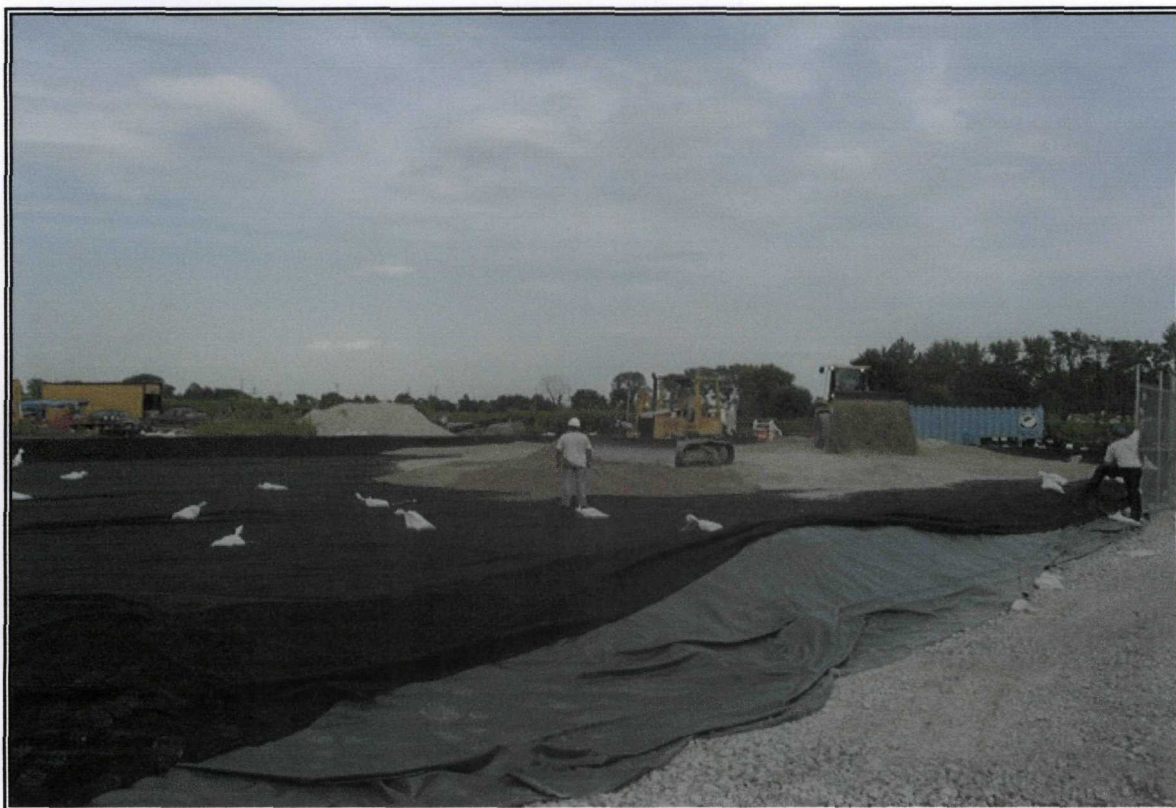
OFFICIAL PHOTOGRAPH NO. 22
U.S. ENVIRONMENTAL PROTECTION AGENCY

Subject: Construction of the bermed liner for the wastewater treatment system.

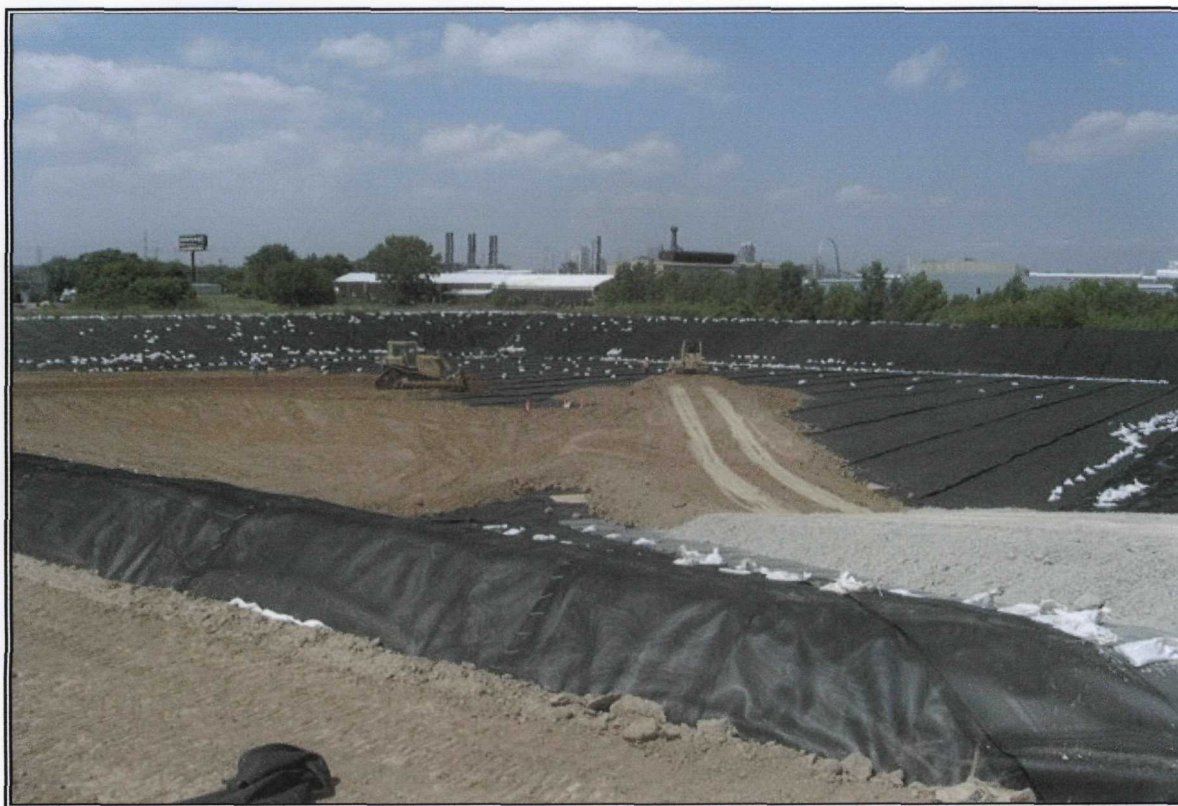
OFFICIAL PHOTOGRAPH NO. 23
U.S. ENVIRONMENTAL PROTECTION AGENCY

Subject: Placing fill material over the secondary liner.

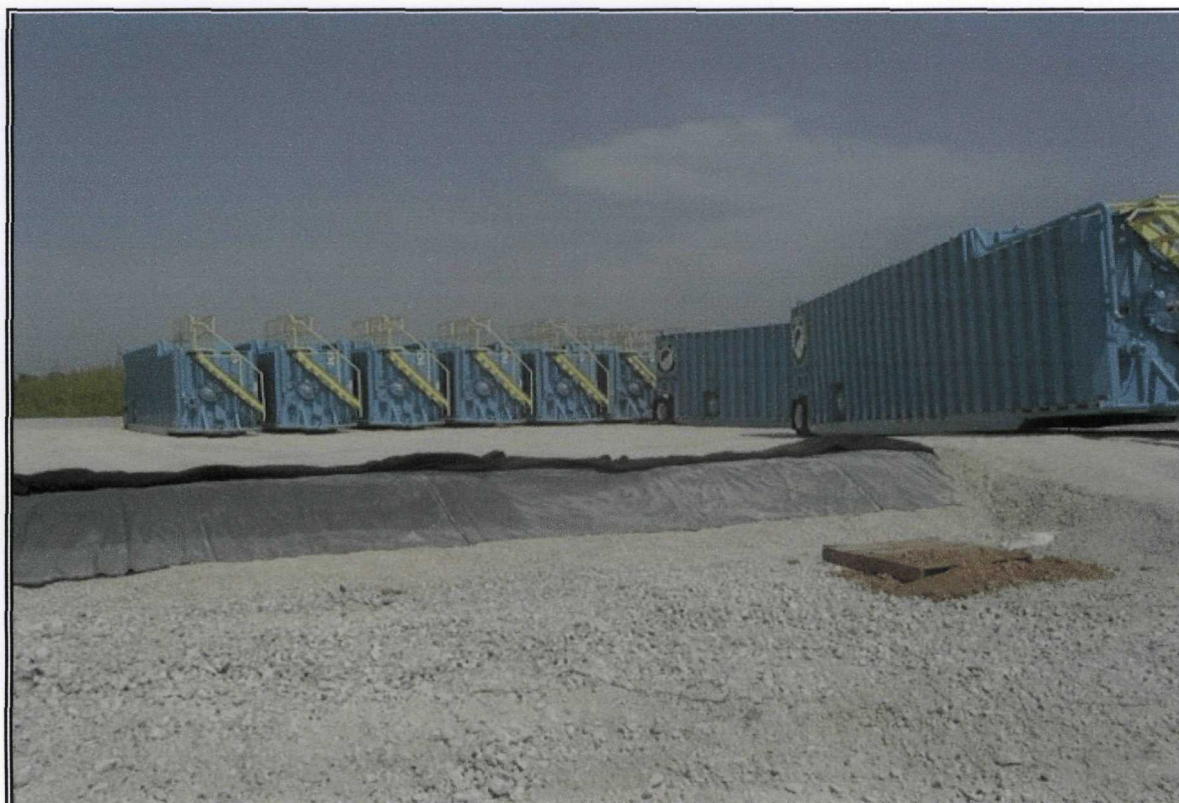
OFFICIAL PHOTOGRAPH NO. 24
U.S. ENVIRONMENTAL PROTECTION AGENCY

Subject: Placing holding tanks in the wastewater treatment berm.
